Issue: HDPE seam defects we cannot see – Panel discussion presentation given by R. Thiel

Geoamericas Geosynthetics Conference, Lima, Peru, May 2012

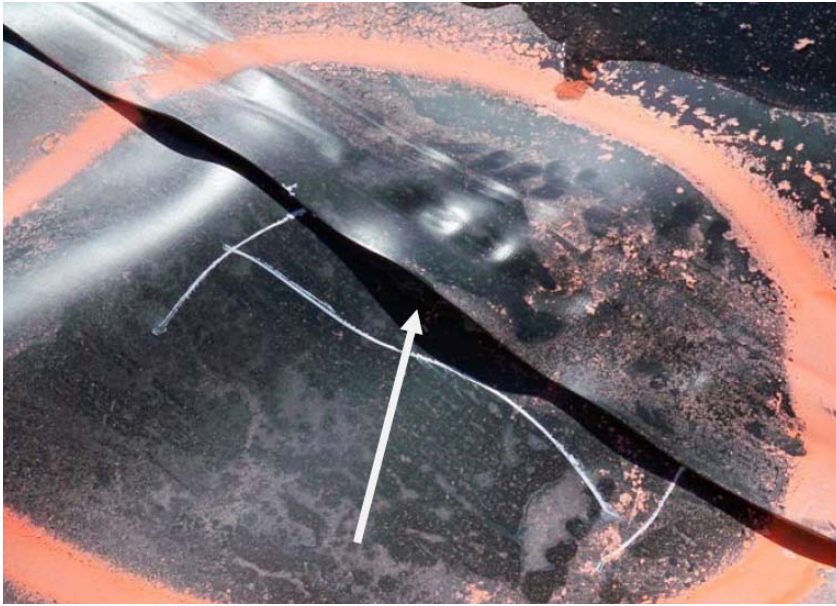
View from above – perfect looking fusion seam.

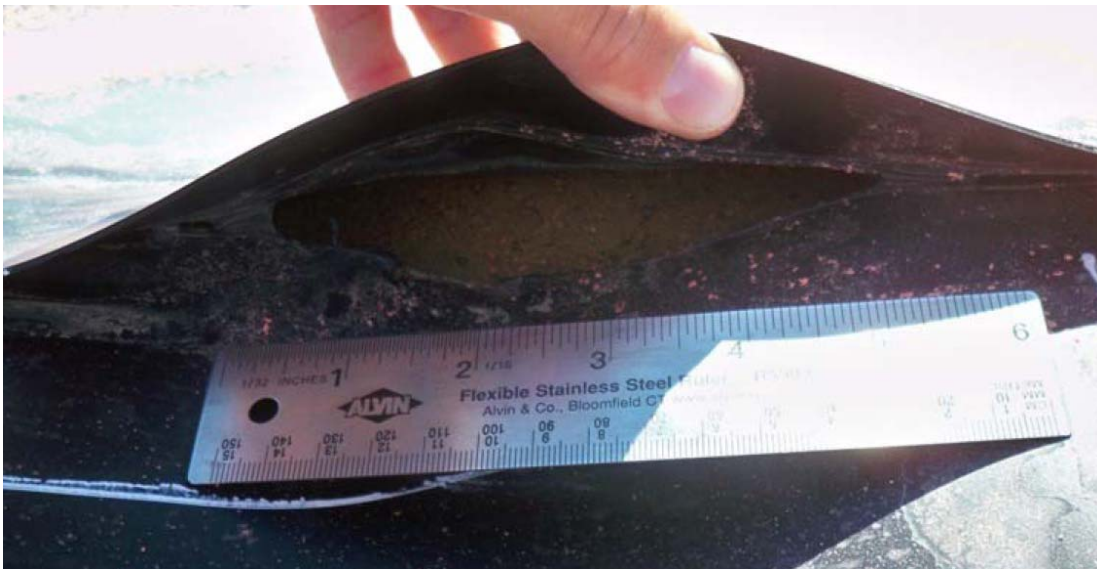
Dramatic example of rip under the flap.

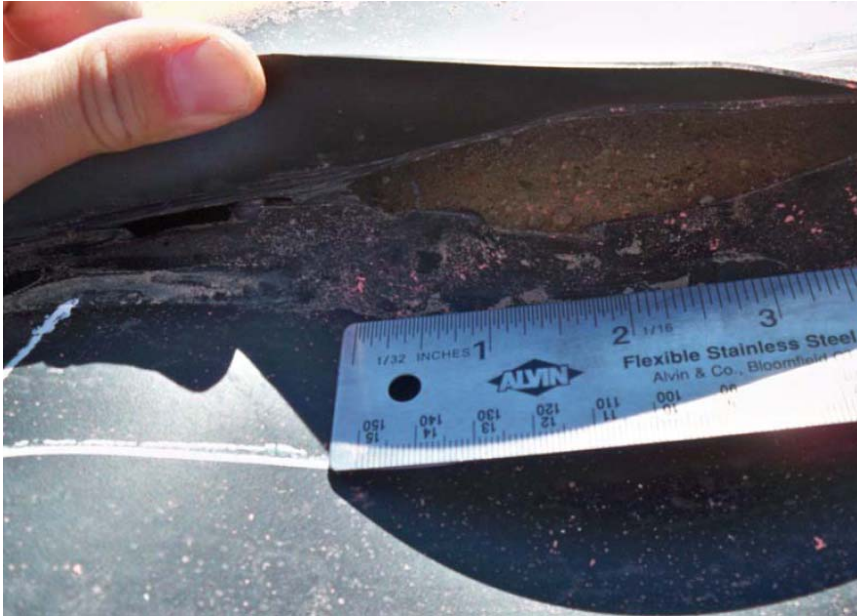
Another close up view of the tear under the flap in 1.5 mm HDPE. Destructive seam tests immediately before and after this location indicated perfect results, and inspection of the seam cross section looked perfectly good.

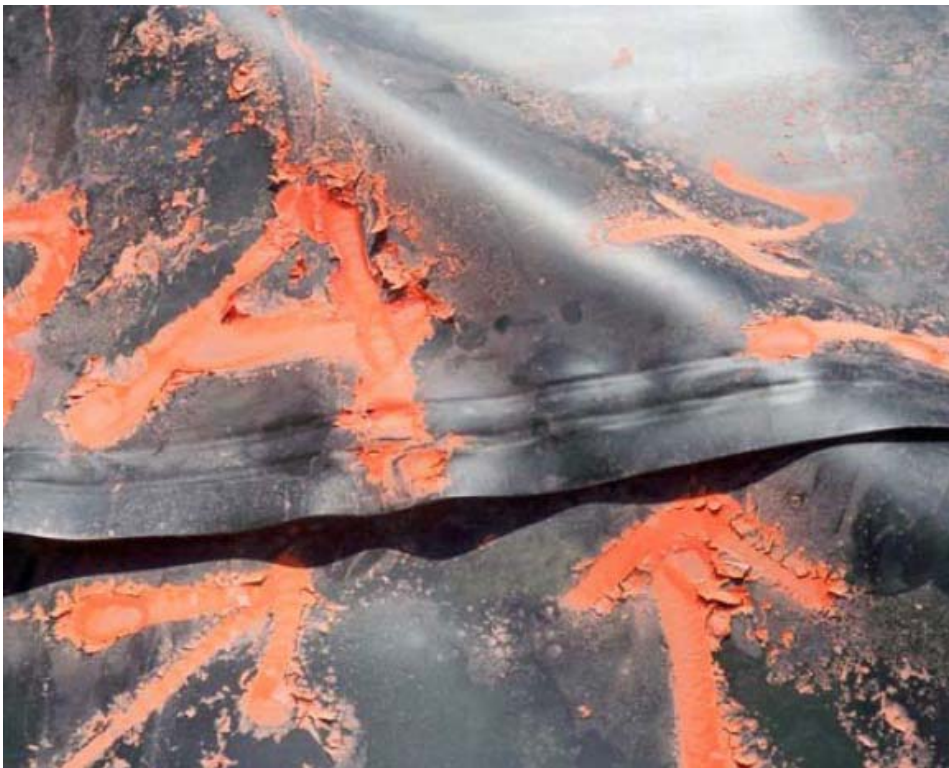
Another location with the lower sheet torn under the flap at the edge of the seam, where the seam looks perfect from above, and destructive tests immediately before and after the problem areas indicate good quality seam.

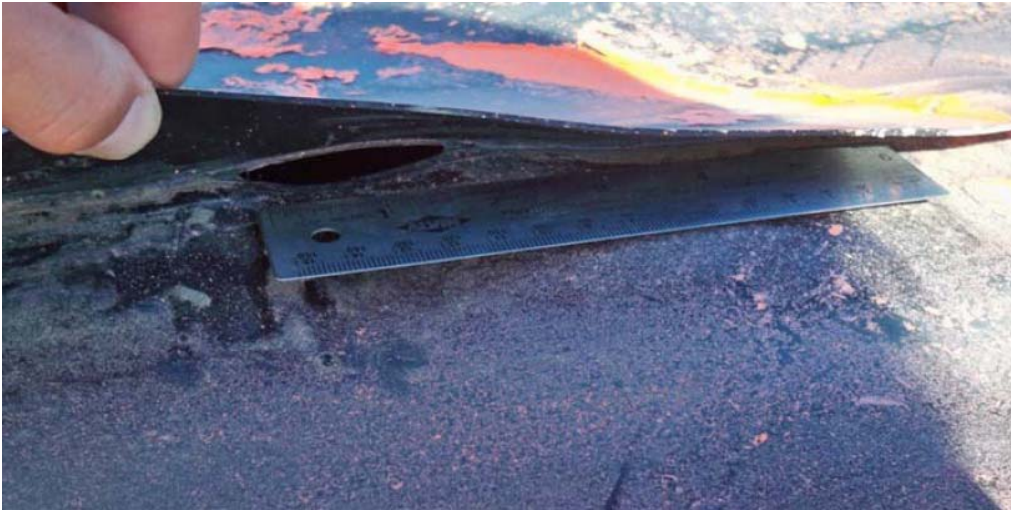
Tear under the flat that would never have been found without water lance survey.

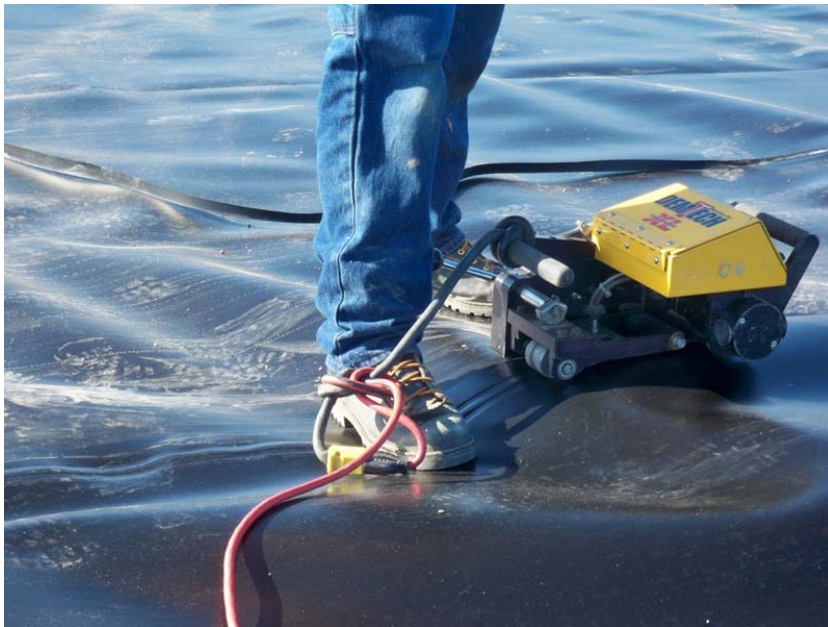
Stepping on the weld just behind the machine, while weld is still hot, to preserve alignment and work with wrinkles

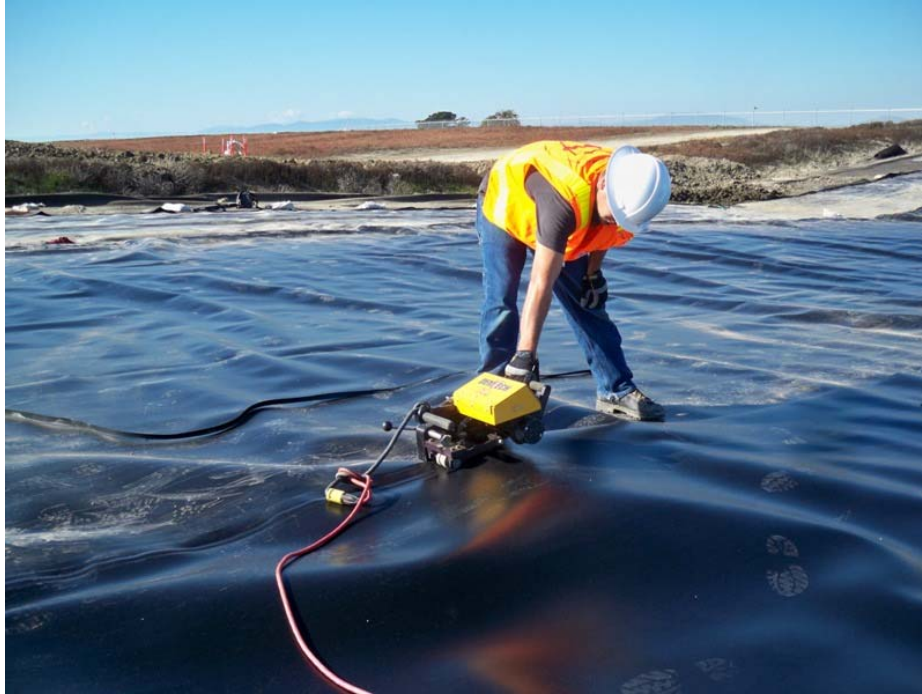
Type of non-visible weld defect	Suspected causes	Possible detection measures
Rip in fusion seam on lower sheet, adjacent to the outside weld track, under the flap	a) Re-alignment of welding machine, often with a jerking motion, as it is running, especially on hot days	1. Vigilant observation of every weld operation and marking of any alignment adjustments 2. Hand probe or air lance all flaps 3. Water-puddle/lance ELL survey (NEED TO GO SLOW AND GET WATER UNDER THE FLAP)
Cuts under the outer flap of fusion seam	a) Trimming the upper sheet b) sharp material (e.g. rock) caught on the machine plate	1. Vigilant observation of every single cutting procedure and allowing only hook blades 2. Vigilant cleaning of debris 3. Water-puddle/lance ELL survey (NEED TO GO SLOW AND GET WATER UNDER THE FLAP)
Incipient tear in lower sheet of extrusion welds that fail after a few days or weeks	a) Excessive thermal input causing large deformations, thinning of sheet, and stress-concentrating crimps under the weld bead b) Excessive grinding of lower sheet outside the weld zone	1. Vigilant observation of every single extrusion weld for both preparation and execution 2. Moderate field stress (e.g. “kick”) all extrusion welds after one week of exposure 3. Other? (e.g. IR)

Re-aligning machine during welding

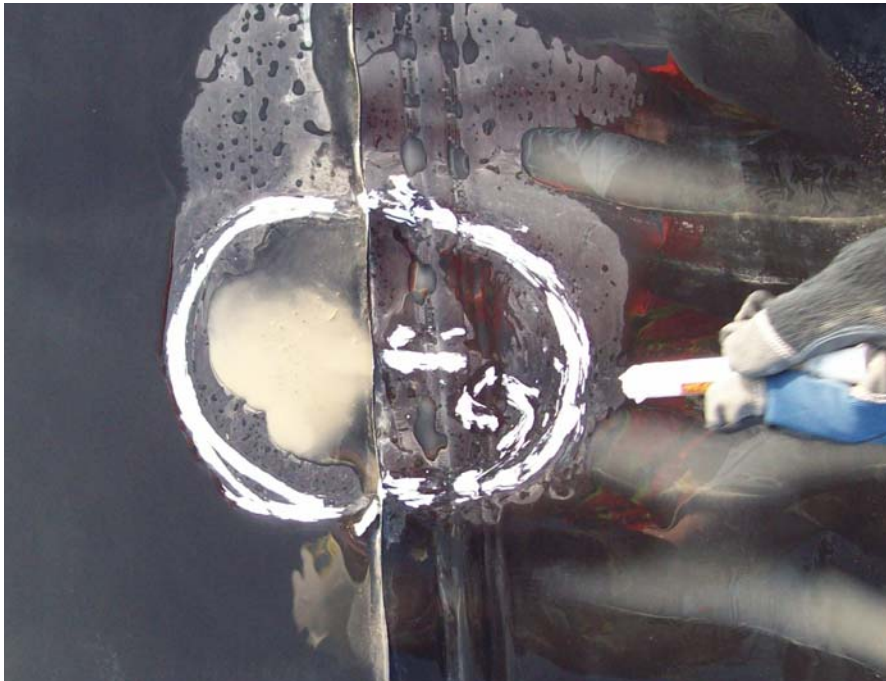
Leak under flap: Seam appears perfect from above.

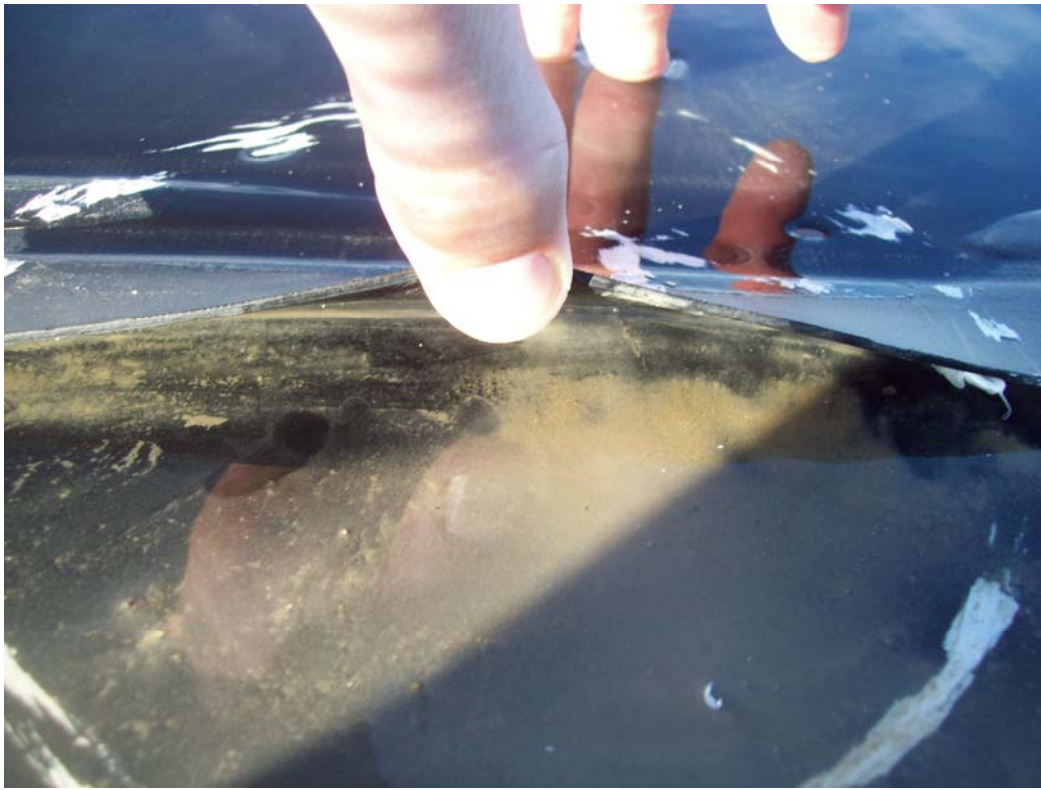
Seam separation appears when flap is lifted, although air channel is intact.

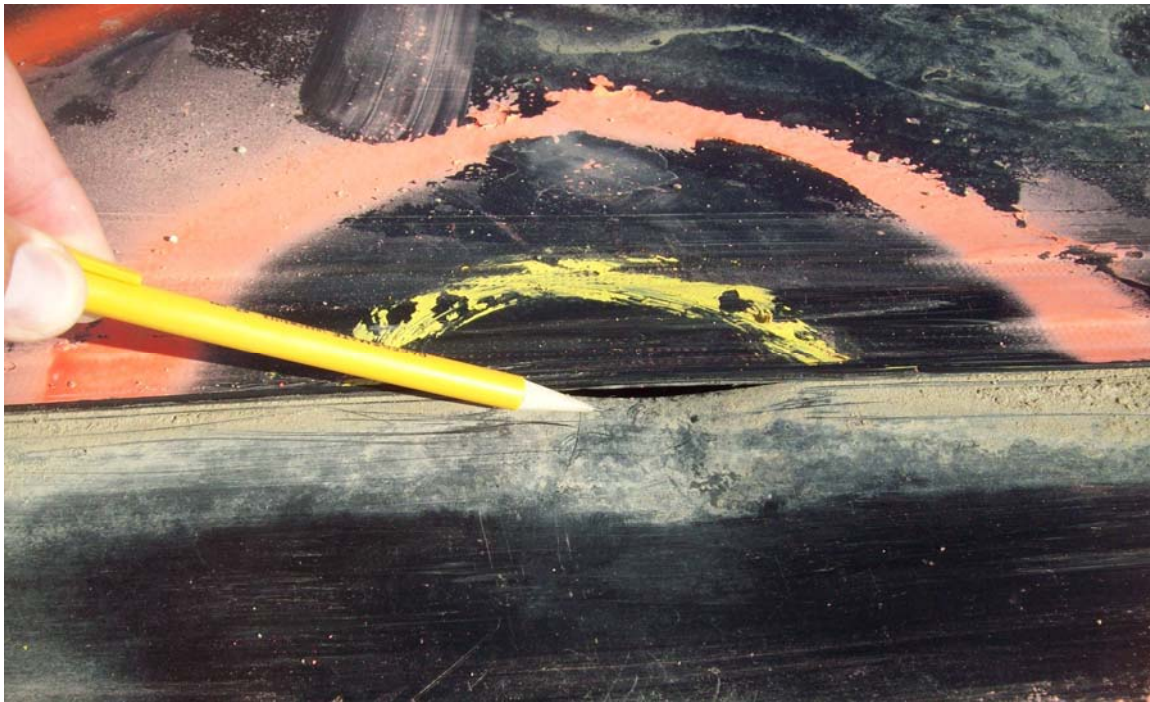
Seam separation is clearly visible after the flap has been completely cut away.

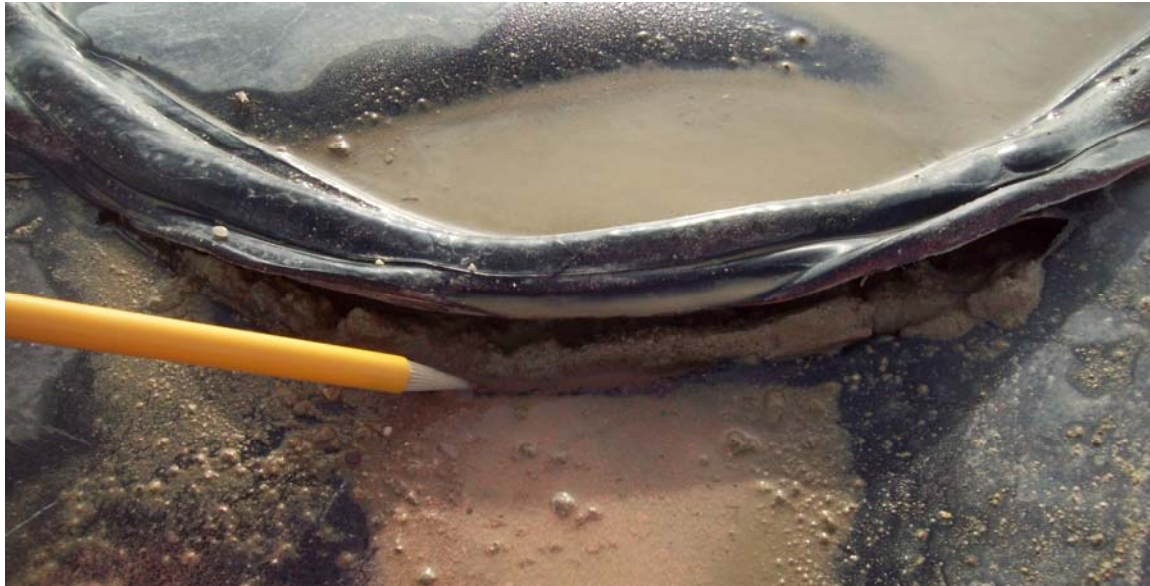
Extrusion weld cracks open after a week of exposure – it is a tear in the lower sheet that has been severely thinned.

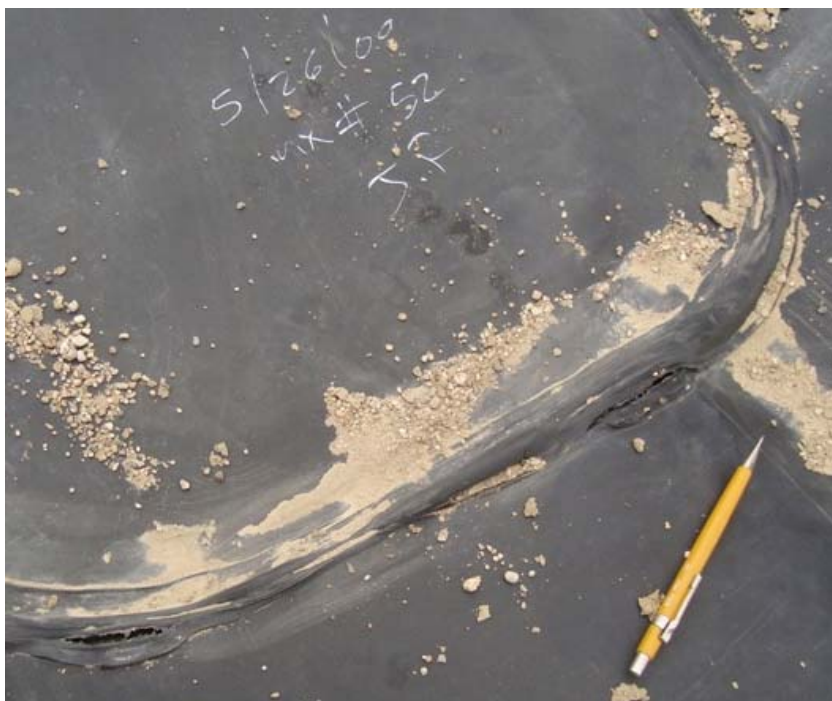
Same story as above – two separate tears in lower sheet. Note QC sign-off on the patch.

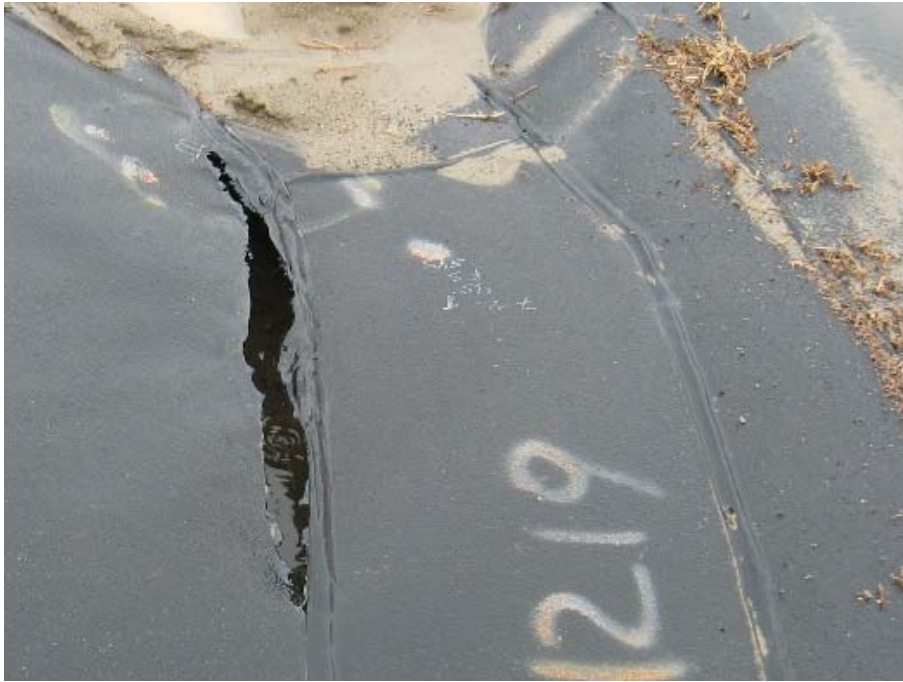
Tear in lower sheet that propagated months later.

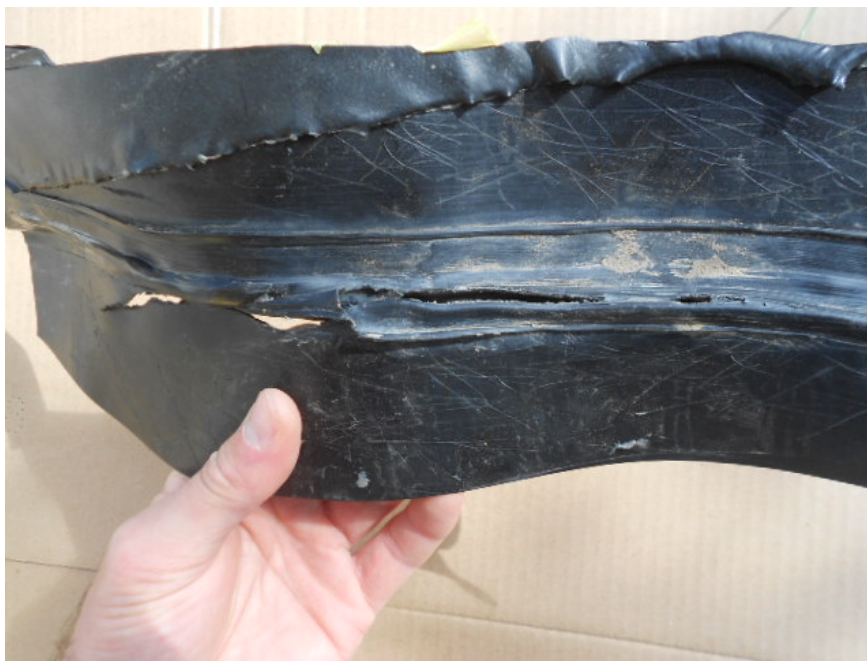
View of cracked extrusion weld.

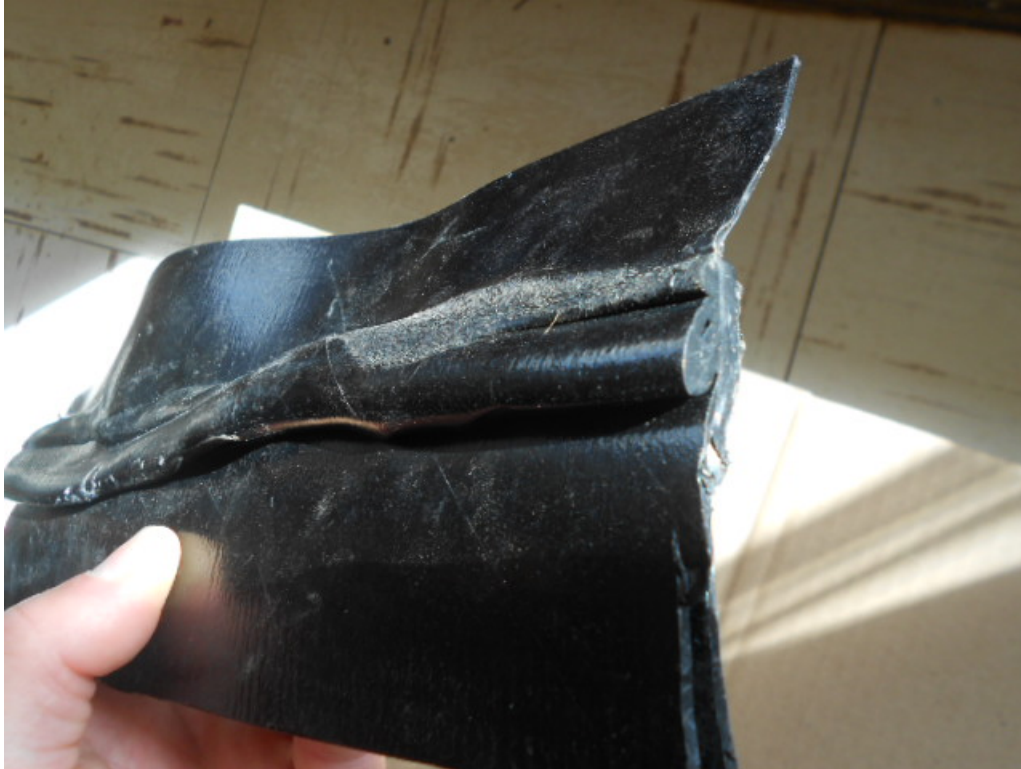
View of severely overheated extrusion weld from below.

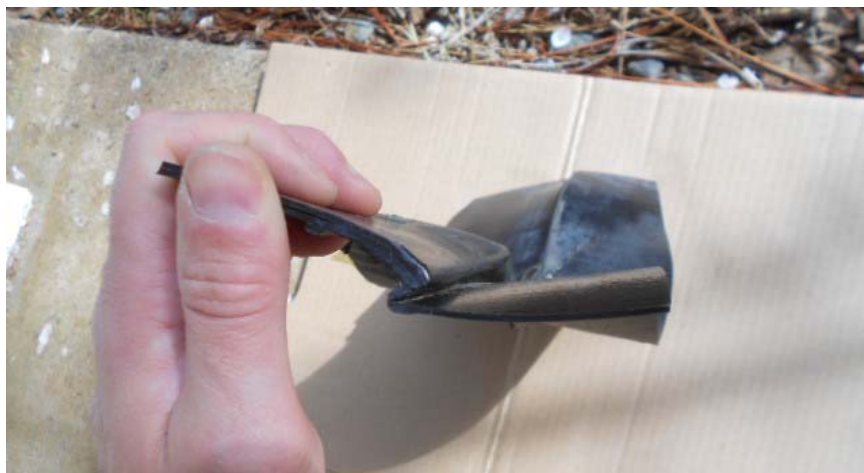
Bottom side of overheated extrusion weld.

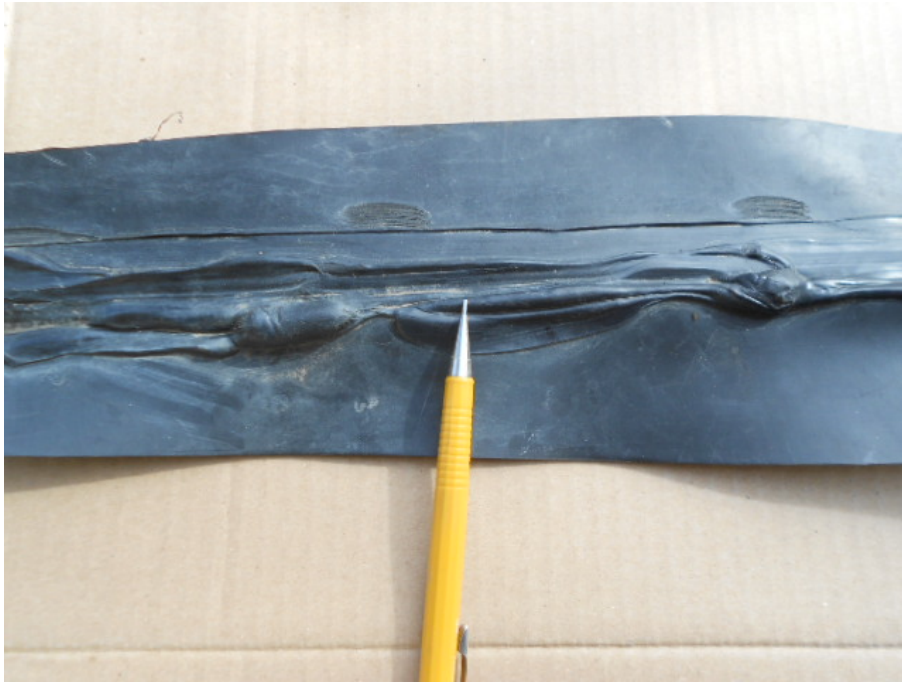
View from top, and...

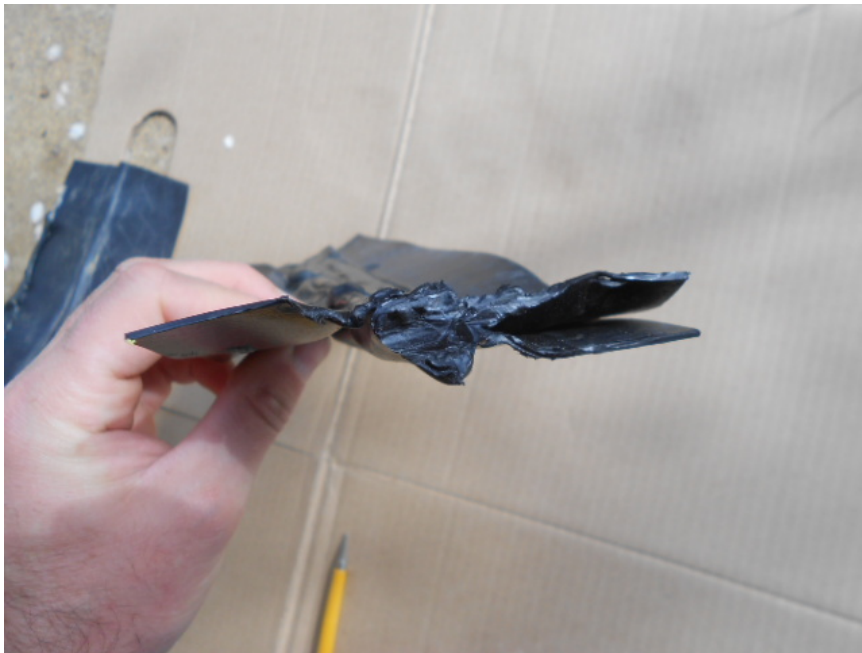
...view from side showing extreme overheating.
