Technical Paper submitted to *Geosynthetics International*, FINAL JULY 5, 2011

GEOMEMBRANE DAMAGE DUE TO STATIC AND CYCLIC SHEARING OVER COMPACTED GRAVELLY SAND

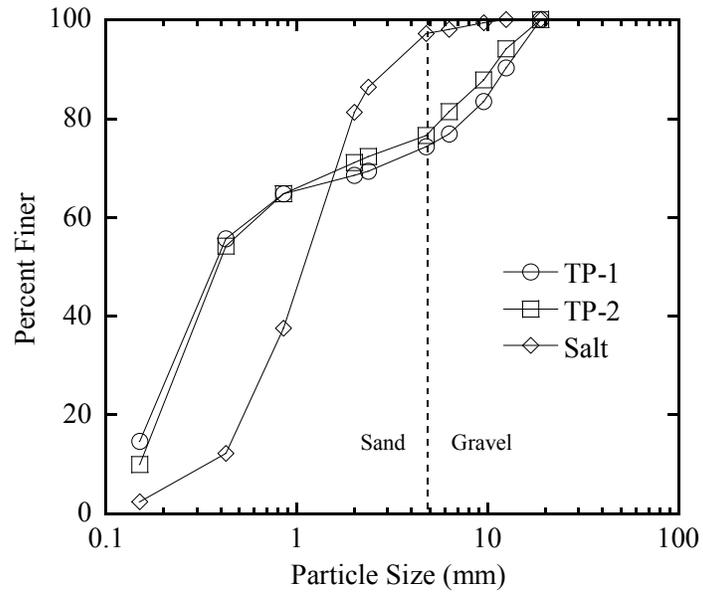
Figure 1. Particle size distribution curves.

Subgrade soil samples were obtained on site from two test pits (TP-1, TP-2). Initial moisture contents w are provided in Table 2. Each soil sample was passed through a 19 mm sieve to remove large particles and the subsequent particle size distribution curves are shown in Figure 1. The soils had similar textures consisting of gravelly sand with pieces of white caliche. A Standard Proctor test was conducted on each soil sample and the optimum moisture contents are provided in Table 2. Once the optimum moisture contents were established, each soil was prepared to a moisture content 2 percent dry of optimum and then the soils were mixed in a 1:1 ratio to create the final subgrade soil for the experimental program. The final subgrade had 25 percent gravel content.

Potash salt from the field site was passed through a 12.7 mm sieve and the subsequent particle size distribution curve is shown in Figure 1. The salt consisted almost entirely of sand-sized particles (3 percent gravel) and had an initial moisture content of 0.8 percent (Table 2).

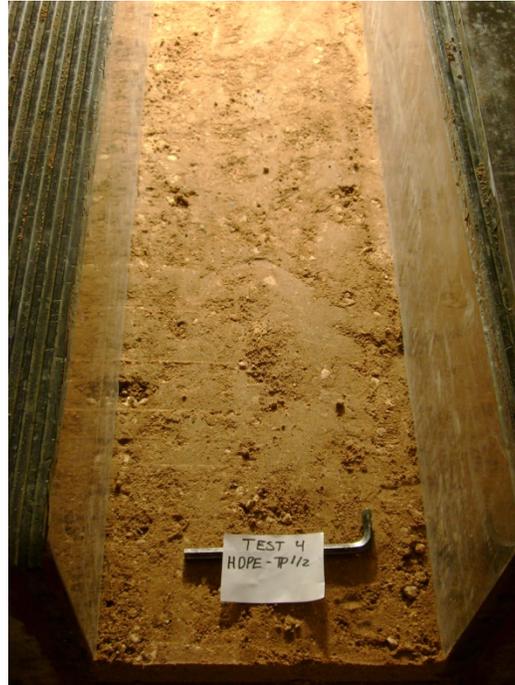
Figure 2. Typical surface of subgrade soil prior to placement of geomembrane.

Each test specimen consisted of subgrade, geomembrane, and potash salt. Subgrade soil was compacted in three lifts to a final thickness of approximately 75 mm. New subgrade soil was used for each test. The first two lifts were heavily compacted using a hand tamper and, to be conservative, the final lift was moderately tamped to provide a rougher surface than would be normally expected in the field. Subgrade soil densities are not available due to the difficulty of measurement. Figure 2 shows a typical view of the subgrade soil after compaction in the test chamber. A specimen of either the LLDPE or HDPE geomembrane was placed on the subgrade with extra length provided on both ends to allow additional geomembrane material to enter the chamber during the shearing process and thus maintain constant shearing surface area. Approximately 50 mm of potash salt was then placed on the geomembrane and lightly tamped. The pullout plate was laid over the salt and a constant normal stress of 958 kPa was applied to the specimen for 24 h. No additional water was provided to the specimen during preparation or testing.

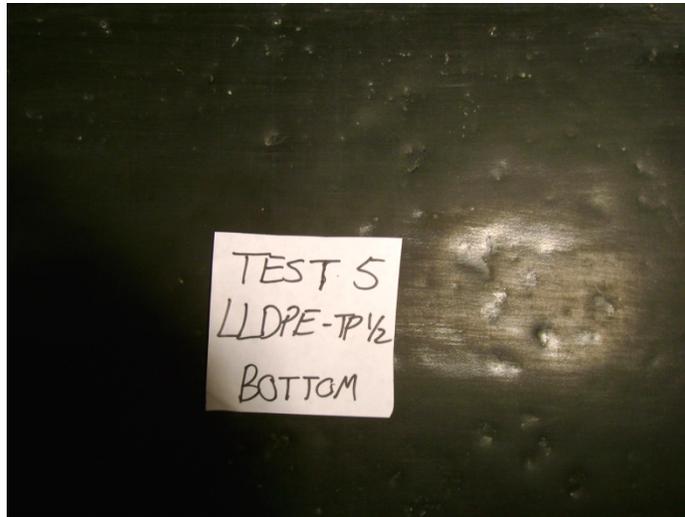
Figure 3. LLDPE geomembrane after static pressure test.

The LLDPE and HDPE geomembranes were relatively undamaged in Tests 5 and 6. Bright light and water integrity tests indicated that no holes were created after the application of static pressure (958 kPa) for 24 h. Both tests produced minor to moderate dimpling of the geomembrane. The dimples resulted from stress concentrations over coarse particles in the subgrade soil. A typical photograph of this effect is shown in Figure 3.

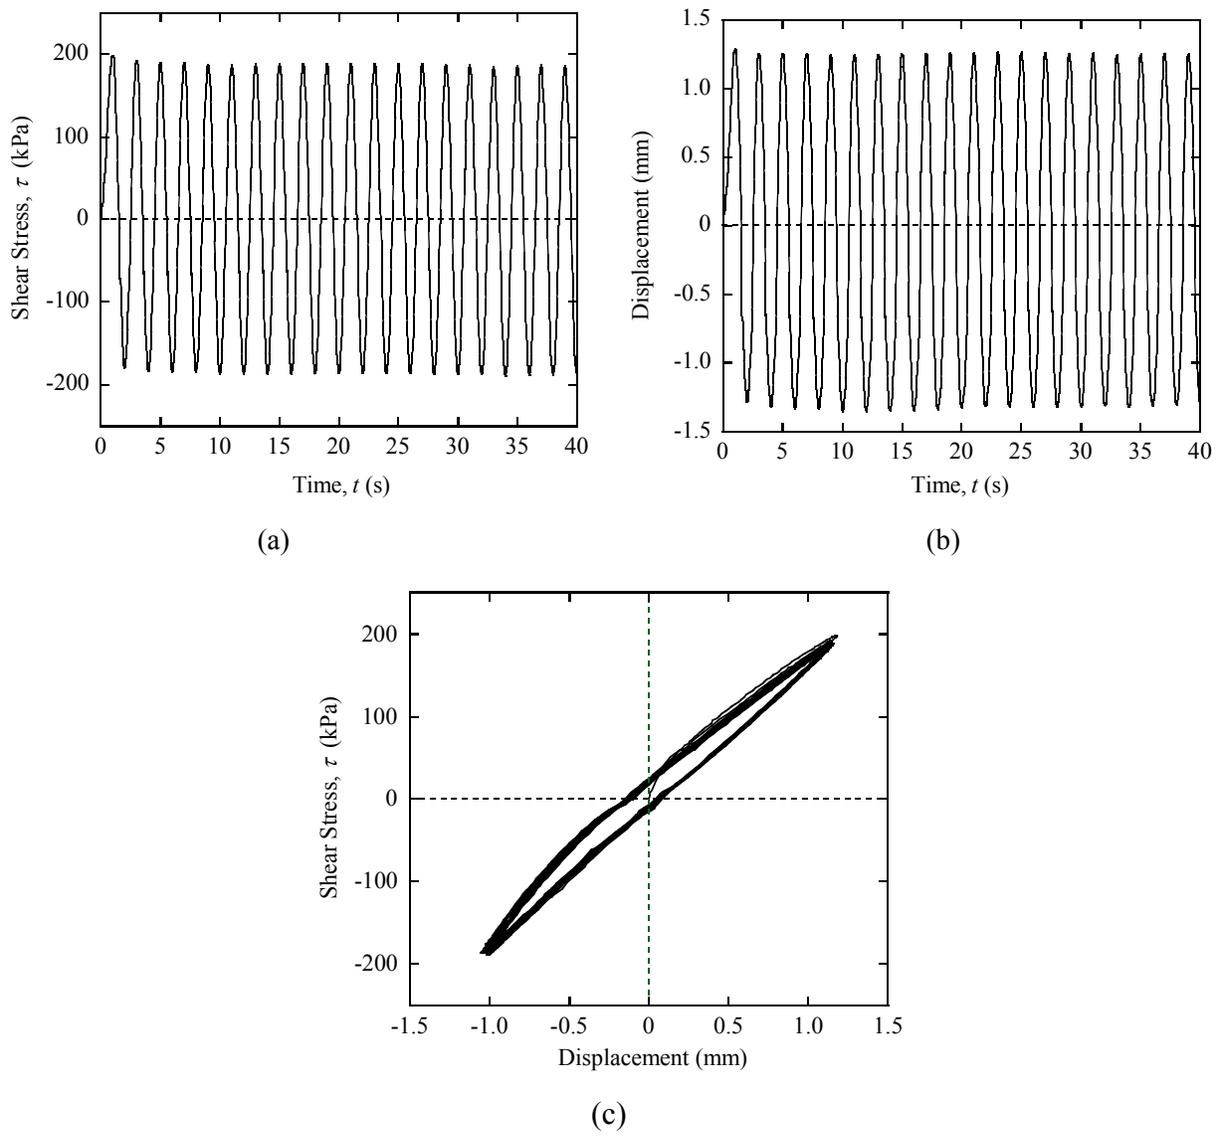
Figure 4. Cyclic loading measurements for LLDPE geomembrane: a) shear stress vs. time, b) shear displacement vs. time, and c) shear stress vs. shear displacement.

Tests 3 and 4 produced cyclic loading data for the test specimens. Post-test inspections indicated that shear failure occurred at the geomembrane/subgrade interface in each case. Figures 4 and 5 present the measured cyclic loading data. The nominal shear stress amplitude of 192 kPa was approximately achieved for 20 sinusoidal cycles at 0.5 Hz. The average shear stress amplitude ranged from 185 to 190 kPa for LLDPE and from 188 to 194 kPa for HDPE. Shear displacements were also essentially sinusoidal and had nearly uniform amplitudes. Measured displacements correspond to shear of each multi-interface specimen as a whole and not specifically the geomembrane/subgrade failure surface. The average displacement amplitude was 1.29 mm for LLDPE and 1.05 mm for HDPE. For both geomembranes, displacement amplitude does not show a consistent trend with increasing number of cycles. The shear stress vs. shear displacement plots display similar hysteresis loops and indicate little change with continued cycling.

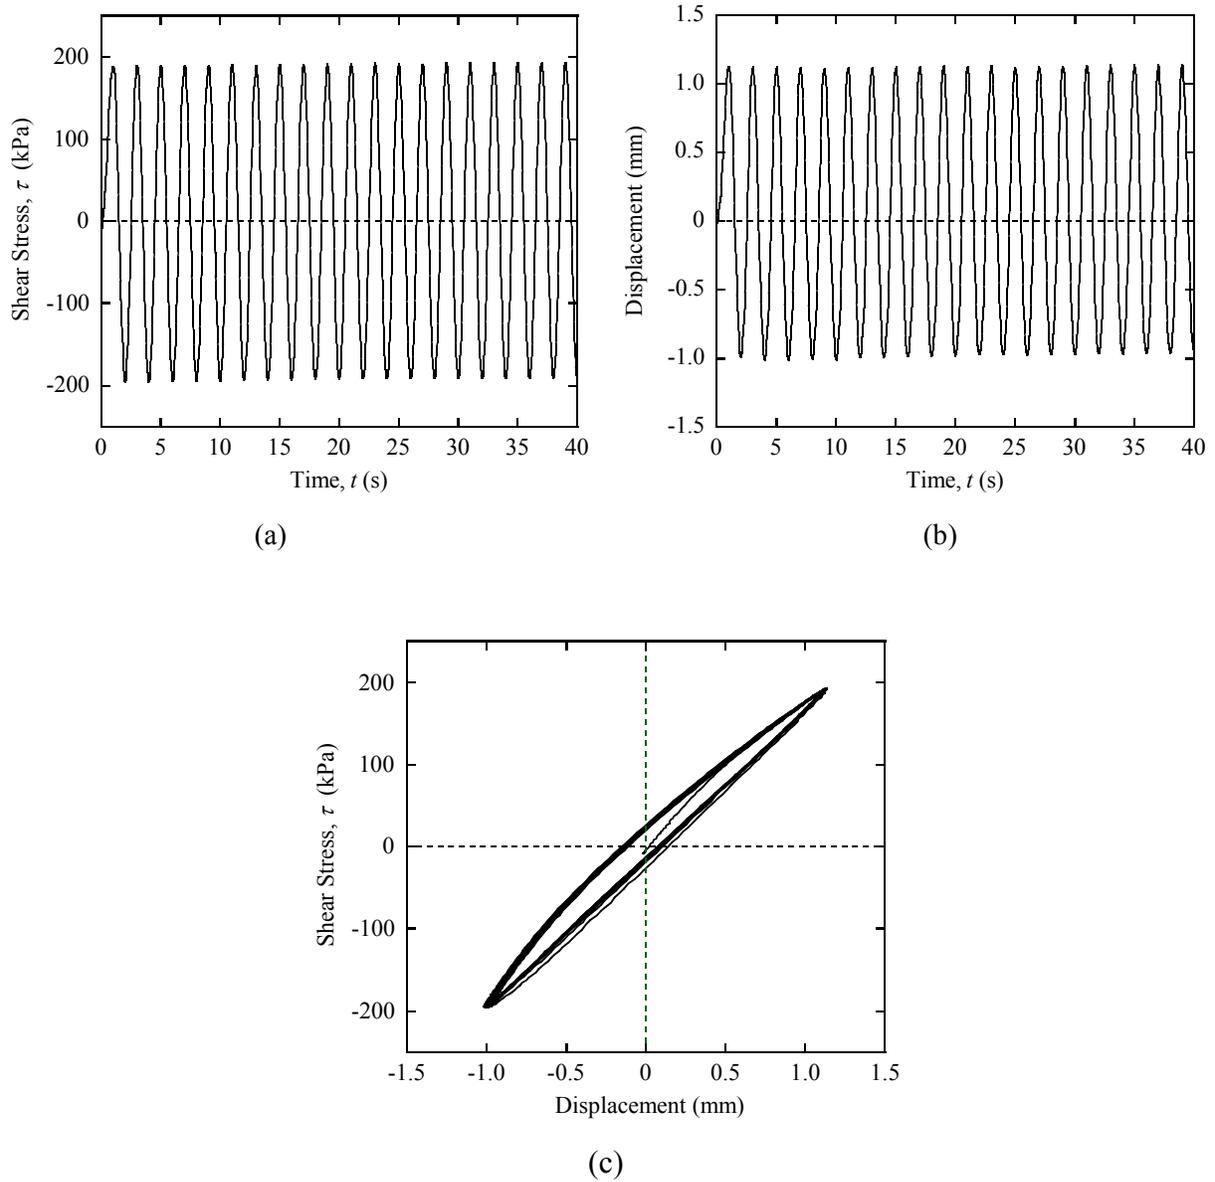
Figure 5. Cyclic loading measurements for HDPE geomembrane: a) shear stress vs. time, b) shear displacement vs. time, and c) shear stress vs. shear displacement.

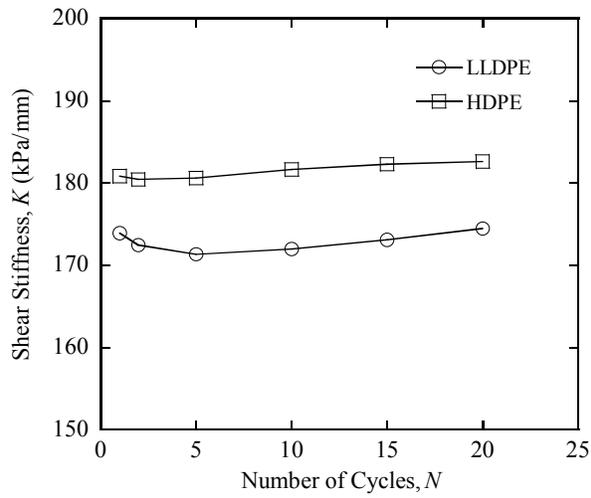
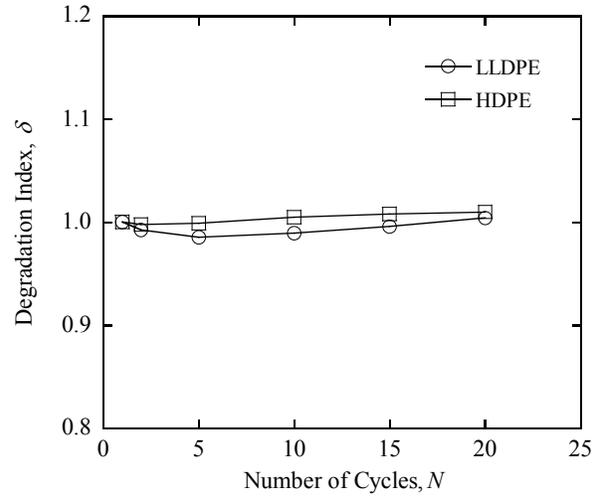
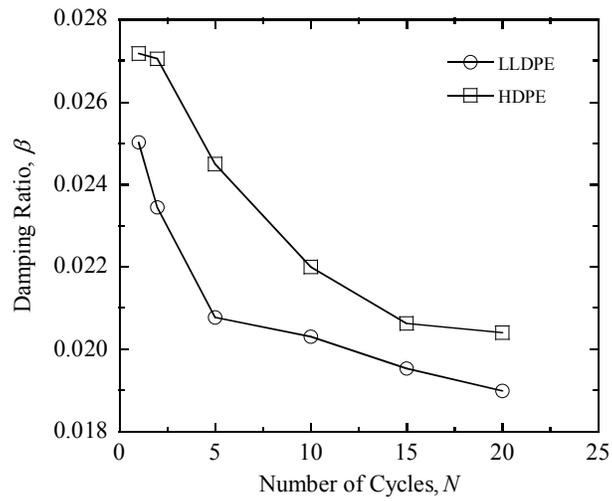
Figure 6. Cyclic loading parameters: a) shear stiffness, b) degradation index, and c) damping ratio.

Cyclic shear parameters were calculated using the method of Nye and Fox (2007) and are shown in Figure 6. Values of shear stiffness were slightly higher for the HDPE geomembrane because shear displacements were slightly lower. Higher interface shear stiffness is also consistent with the higher density and stiffness of HDPE. Shear stiffness for both geomembranes was essentially constant with continued cycling because displacement amplitude was essentially constant, which is also indicated by constant values of stiffness degradation index. Damping ratios for both geomembranes decreased with increasing number of cycles and were consistently higher for HDPE than for LLDPE. Area reduction of the hysteresis loops with continued cycling is responsible for the decreases in damping ratio.

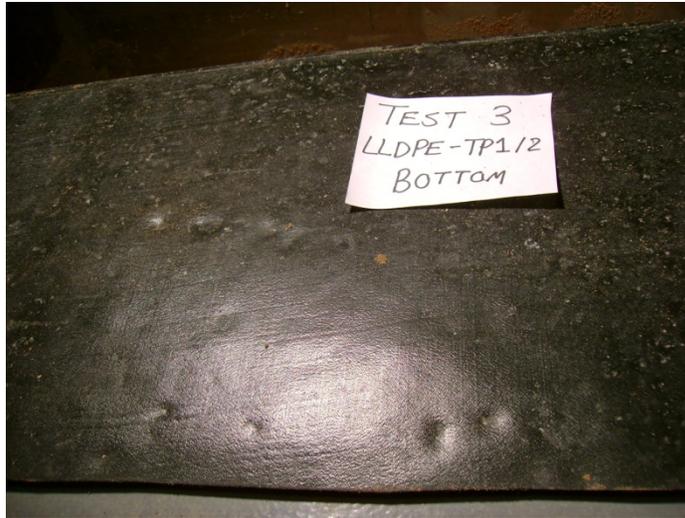
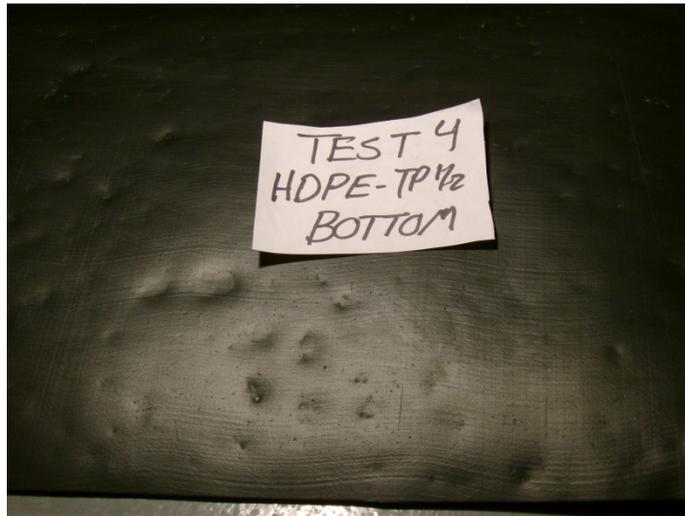
Figure 7. Geomembrane specimens after cyclic loading: (a) LLDPE, (b) HDPE.

Figure 7 presents photographs of the LLDPE and HDPE specimens after cyclic loading. Visual inspections revealed moderate dimpling on both specimens that was only slightly more severe than for the static pressure tests (Tests 5 and 6). The bright light and water integrity tests indicated no holes for either geomembrane specimen.

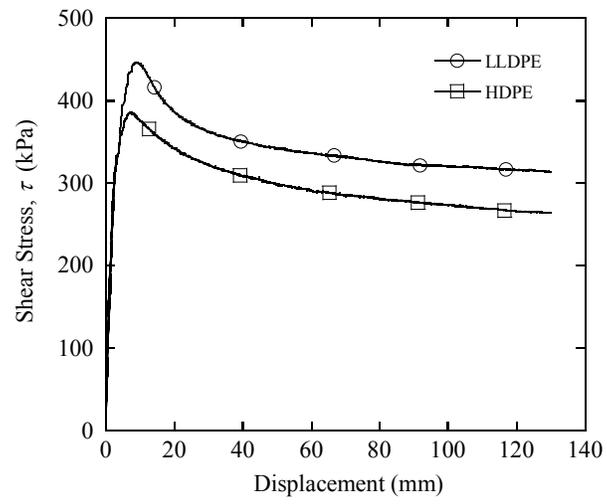
Figure 8. Stress-displacement curves for static shear tests.

After cyclic loading, the geomembranes were sheared to large displacement (130 mm). The shear stress-displacement relationships for both specimens are shown in Figure 8. Shear failure

occurred between the geomembrane and the subgrade soil in each case. Peak (τ_p) and large displacement (τ_{130}) shear strengths and corresponding secant interface friction angles are provided in Table 3. The curves show similar response with the LLDPE specimen yielding higher strengths, which is likely due to the greater ability of this geomembrane to conform to undulations of the rough soil subgrade. Peak and large displacement secant friction angles for LLDPE are larger than HDPE by approximately 3°.

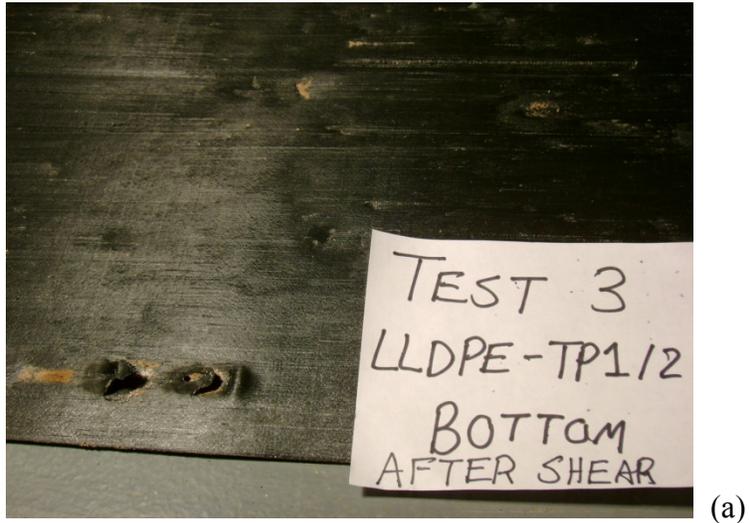
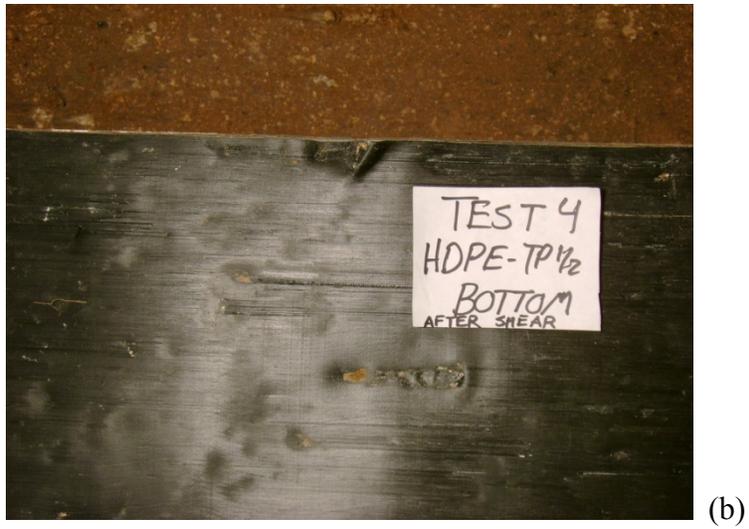
Figure 9. Geomembrane specimens after cyclic loading and static shear: (a) LLDPE, (b) HDPE.

Post-test visual inspections indicated that the underside of both geomembranes experienced significant damage as a result of interface shear. Damage included severe scratch and gouge marks approximately 130 mm in length and tearing of holes for the LLDPE. Each of the damage marks was associated with a gravel particle protruding from the soil subgrade. Figure 9 shows photographs of the geomembrane specimens. The bright light integrity test revealed two holes in the LLDPE geomembrane and the water integrity test did not reveal any additional holes. No holes were indicated by either integrity test for the HDPE geomembrane. The stiffer HDPE material did not conform as closely to protruding gravel particles and thus experienced less damage during shear. Throughout the testing program, all geomembrane damage was associated with the soil subgrade and no damage occurred from the overlying potash salt.
